# Coal-Fired Electric Plant Coal Bunker Fire

CTLGroup was retained by a power utility company to perform an emergency assessment at its coal-fired electrical power generation plant, due to an equipment fire.

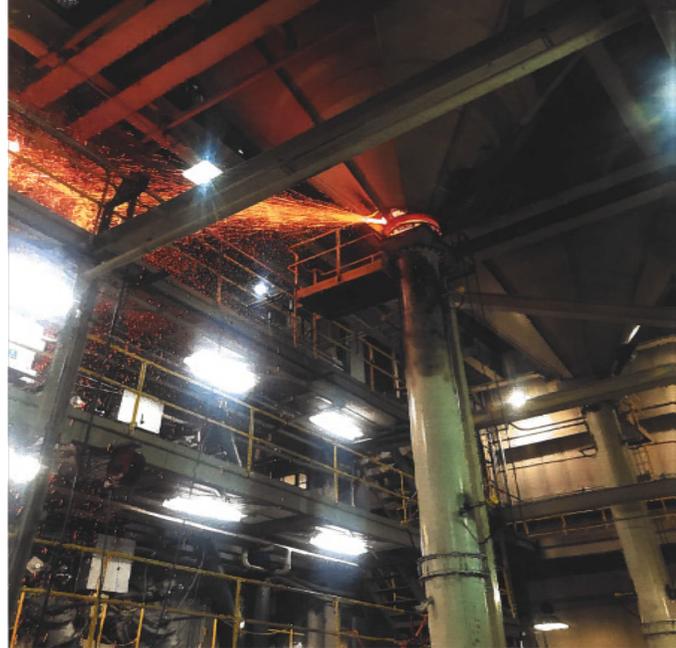
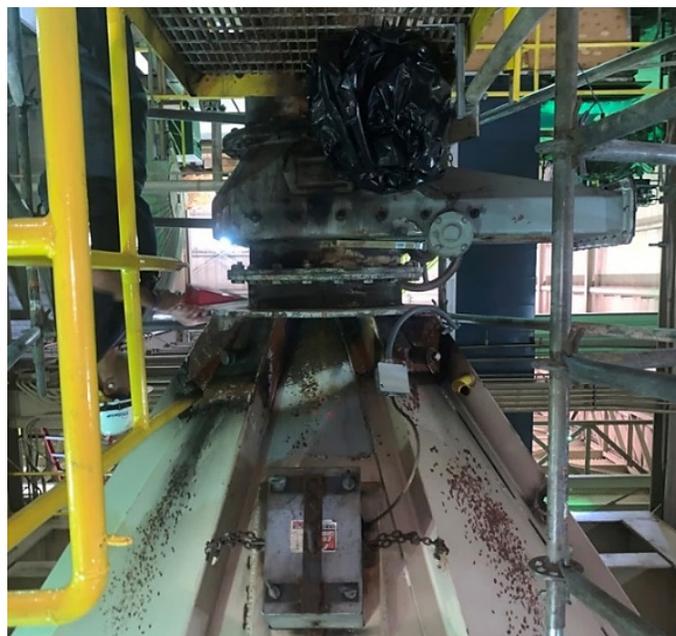
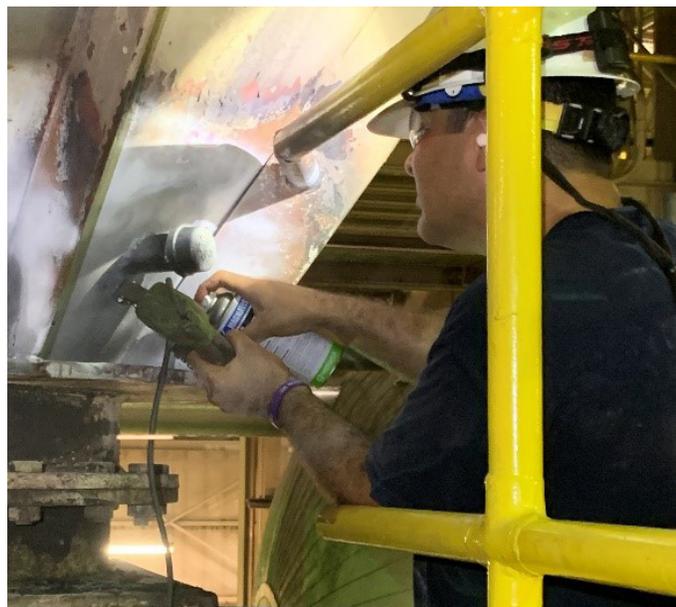
Both the in situ visual inspection and magnetic particle testing revealed no evidence of thermally induced cracks within the bunker plates. The Emergency Response Team also noted that thermal stresses from the fire and containment quench were not significant enough to cause significant distortion of the coal bunker plates, associated hardware, or ancillary transport equipment. Based on assessment of the visual evidence and metallurgical review of the raw materials comprising the coal bunker, hardware, and transport equipment, CTLGroup was able to opine as to the structural integrity of the subject coal bunker. Discussions with responsible utility power plant personnel resulted in performance of minor repairs and the resumed operation of the subject coal bunker, albeit at a reduced capacity and safety margin.
